# Disrupting thermal bridging

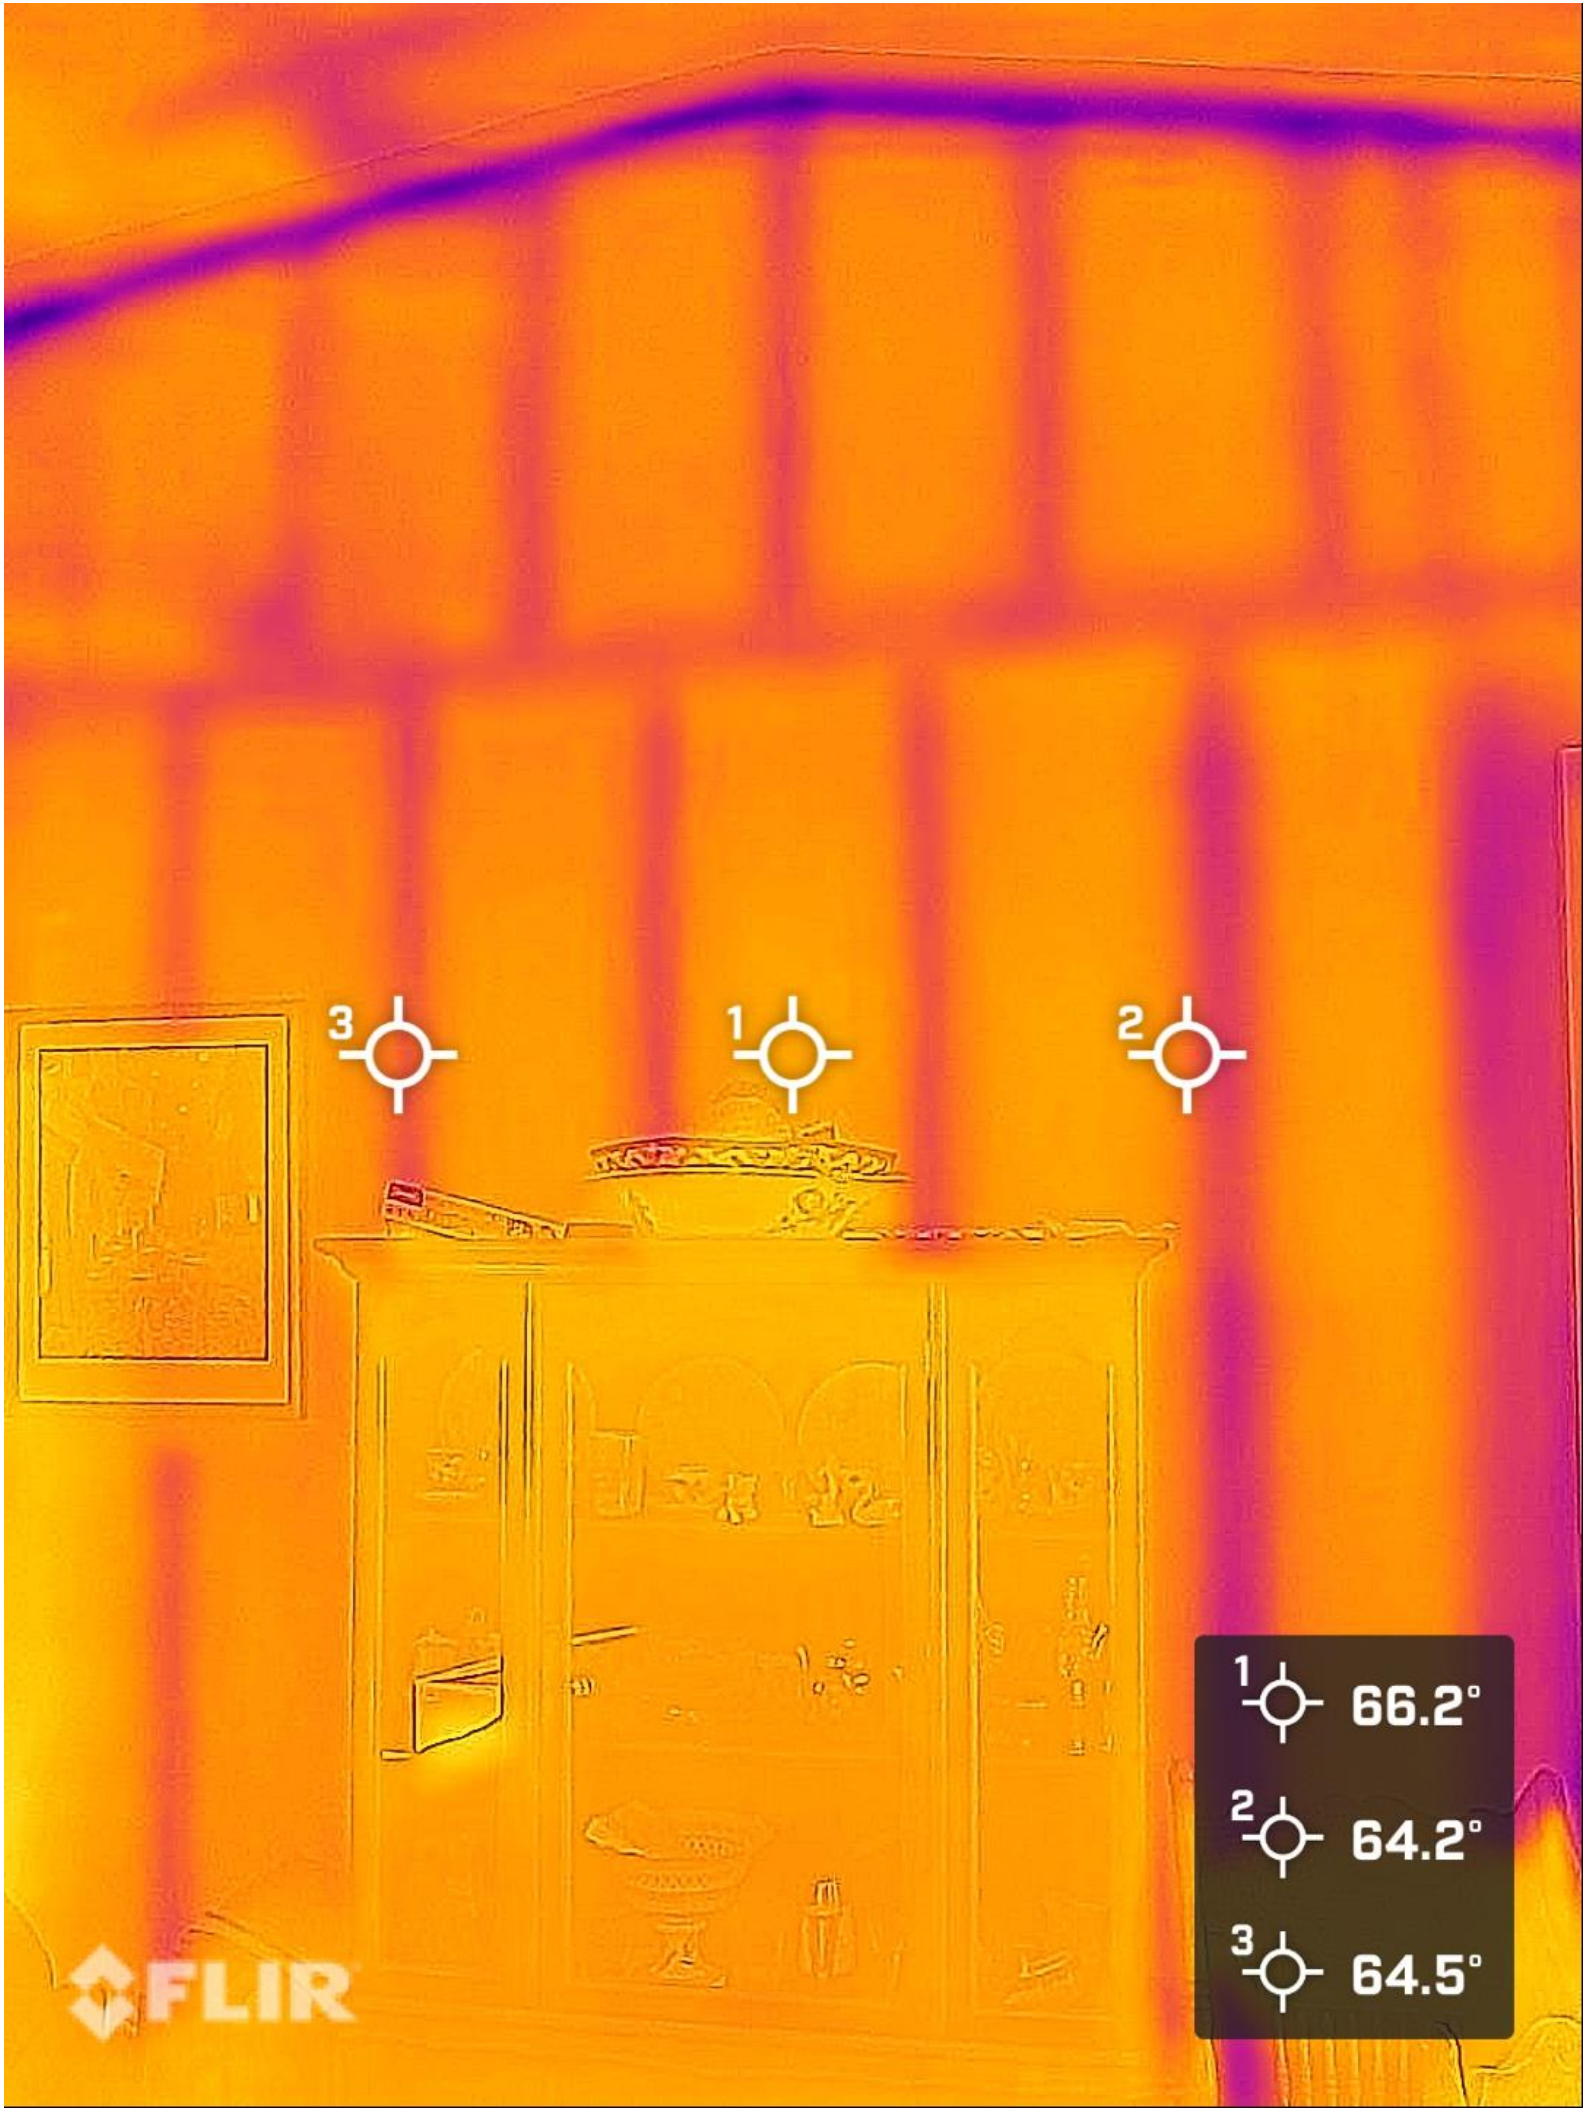
**Standard Wood Stud Wall**

The purple color (bad) is the studs and framing. The gold color (good) is the wall insulation. You can easily see the studs, that is thermal bridging. The framing is colder than the insulation.

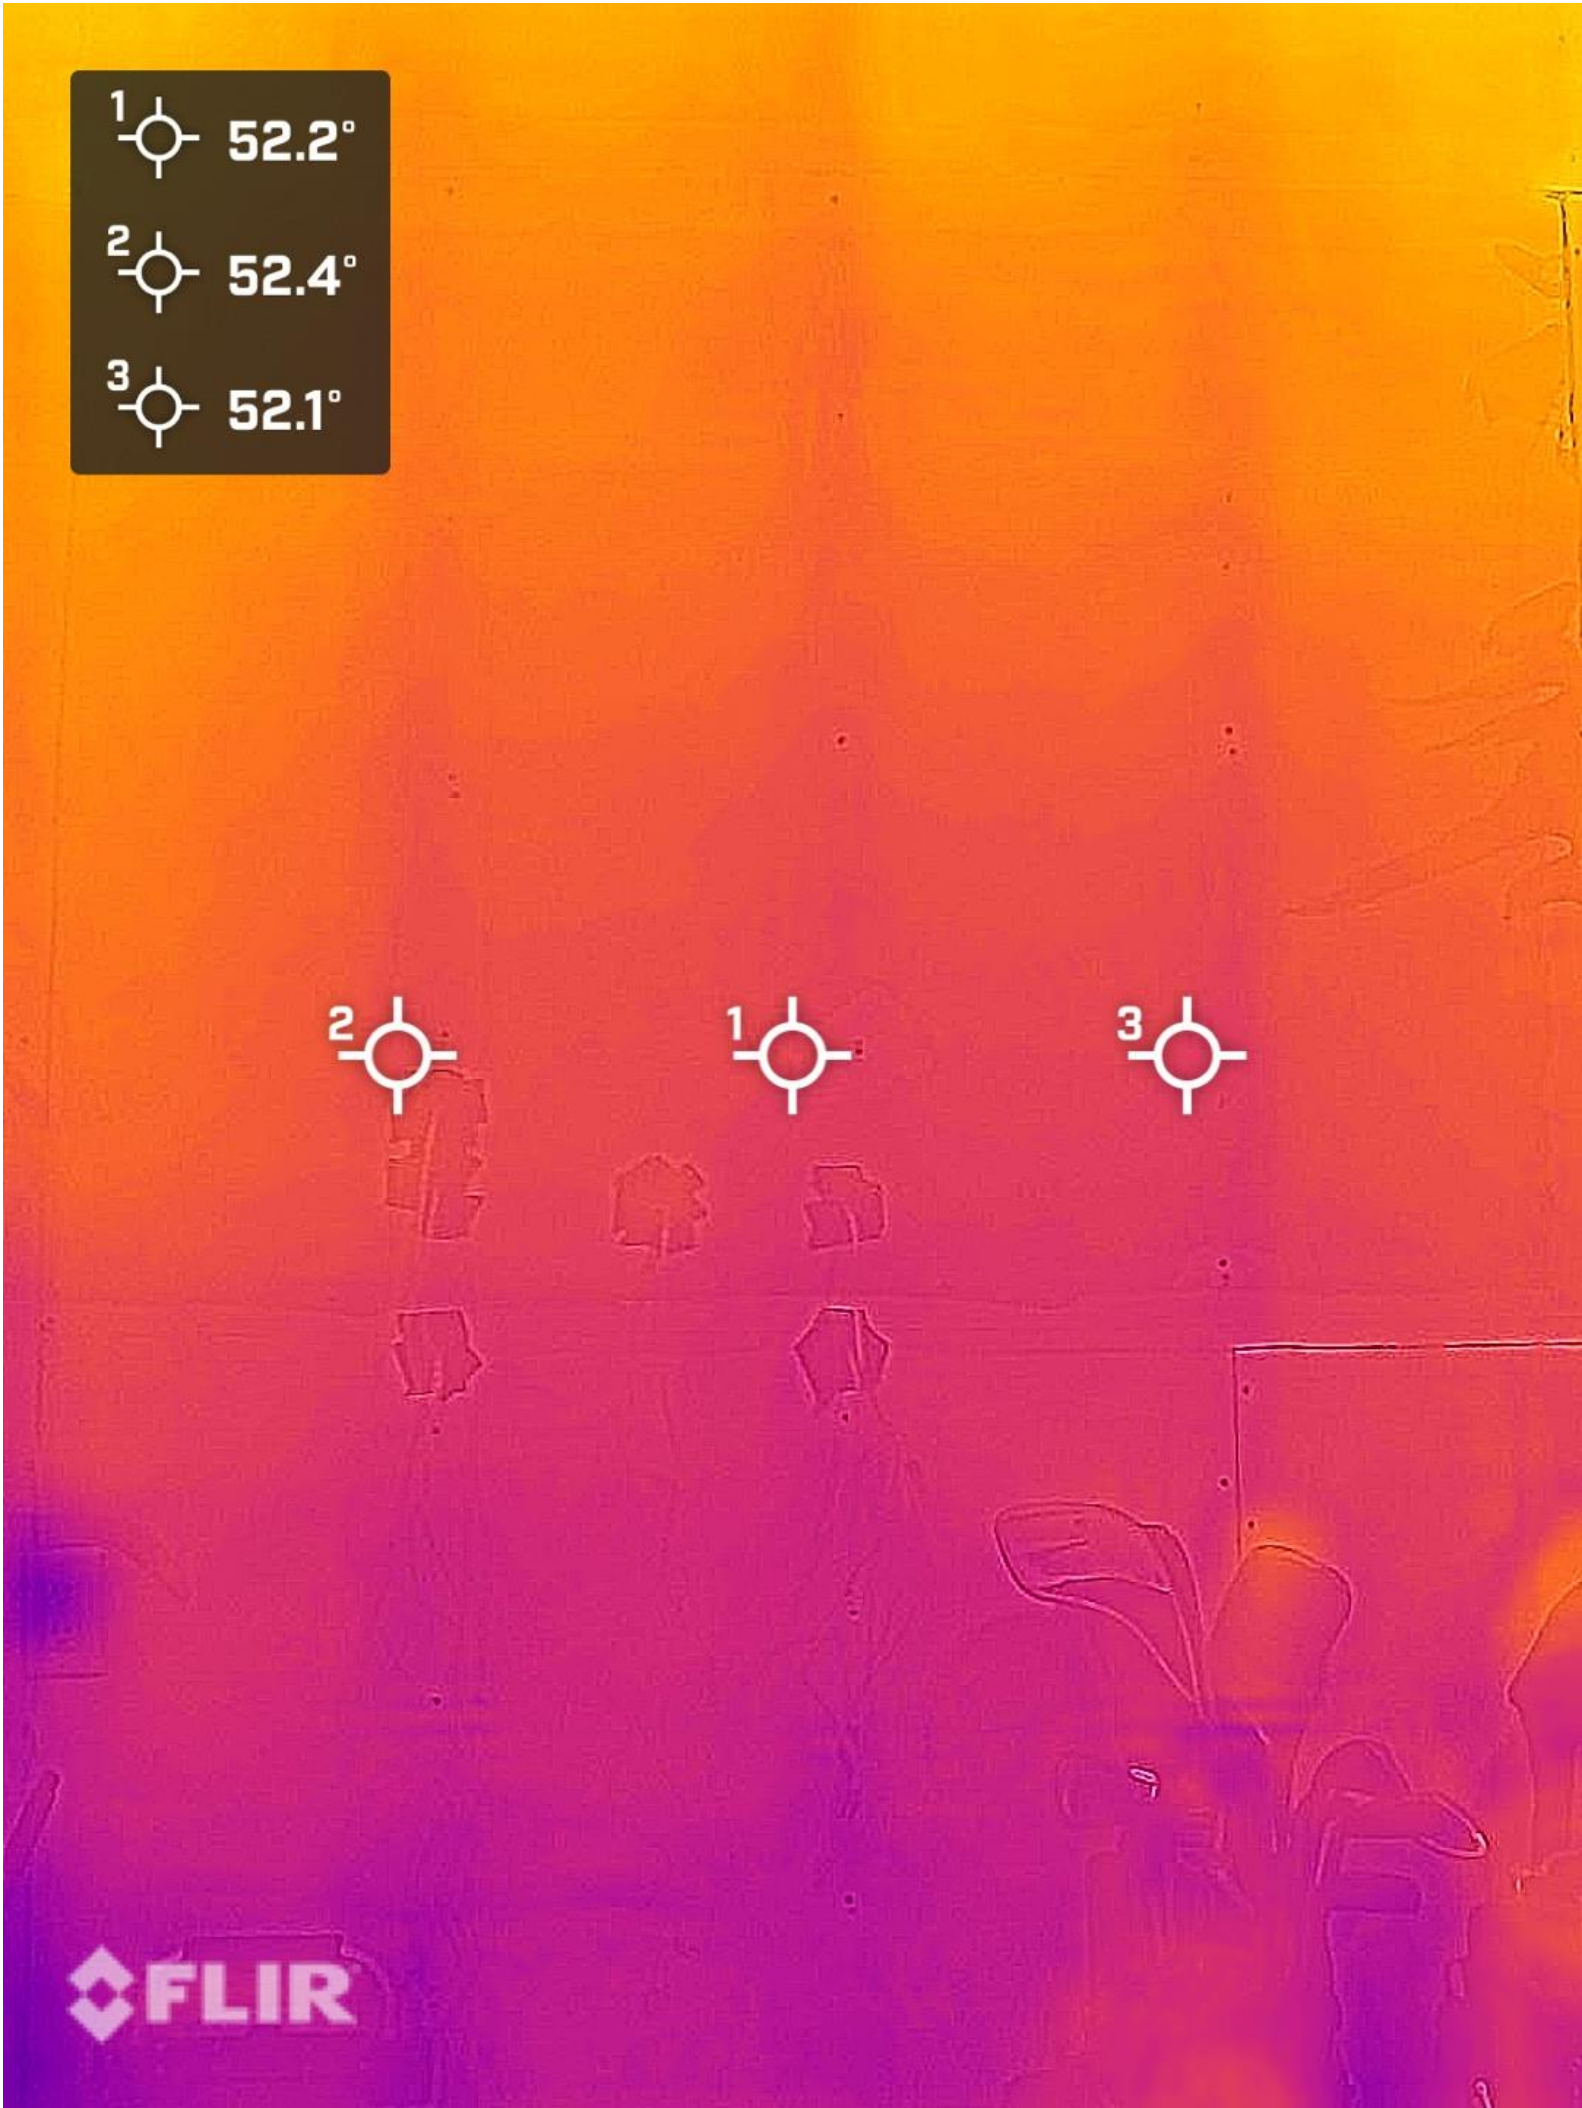
**EcoSmart™ Test Wall**

The Test Wall it's hard to see where the studs are because they are about the same temperature as the insulation. Very little thermal bridging is happening.
